## *History*

### ***Water Quality***

### ***Stormwater Sampling***

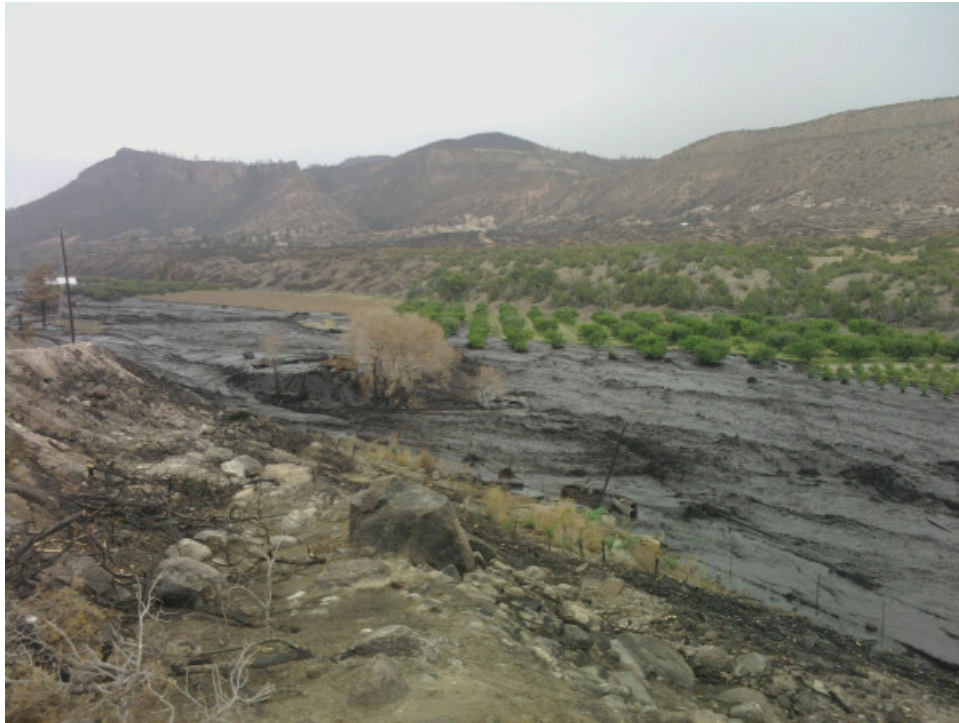
Large stormwater flow event at Dixon Apple Orchard, August 22, 2012. Photograph by Kerry Jones.

7. A station had been located in Cochiti Canyon within the Dixon apple orchard. The station was demolished during large floods through the area. As of the middle of September the Bureau is still attempting to re-locate a new station.

Multiple large floods have occurred in canyons within the Pajarito Plateau. While the Bureau monitoring equipment has been largely unsuccessful in collecting samples or gaging flows during these events, staff is currently making indirect surveys to identify peak flows. The current stations have been replaced, fortified, and have been moderately successful in recording the less extreme flood events. Stormwater samples successfully collected, chemical analysis requested, and expected data delivery dates are shown in the table attached to this document.
